Finndøla hydropower plant

Approval for the use of EKOenergy-ecolabeled sales

Date: 4 July 2017

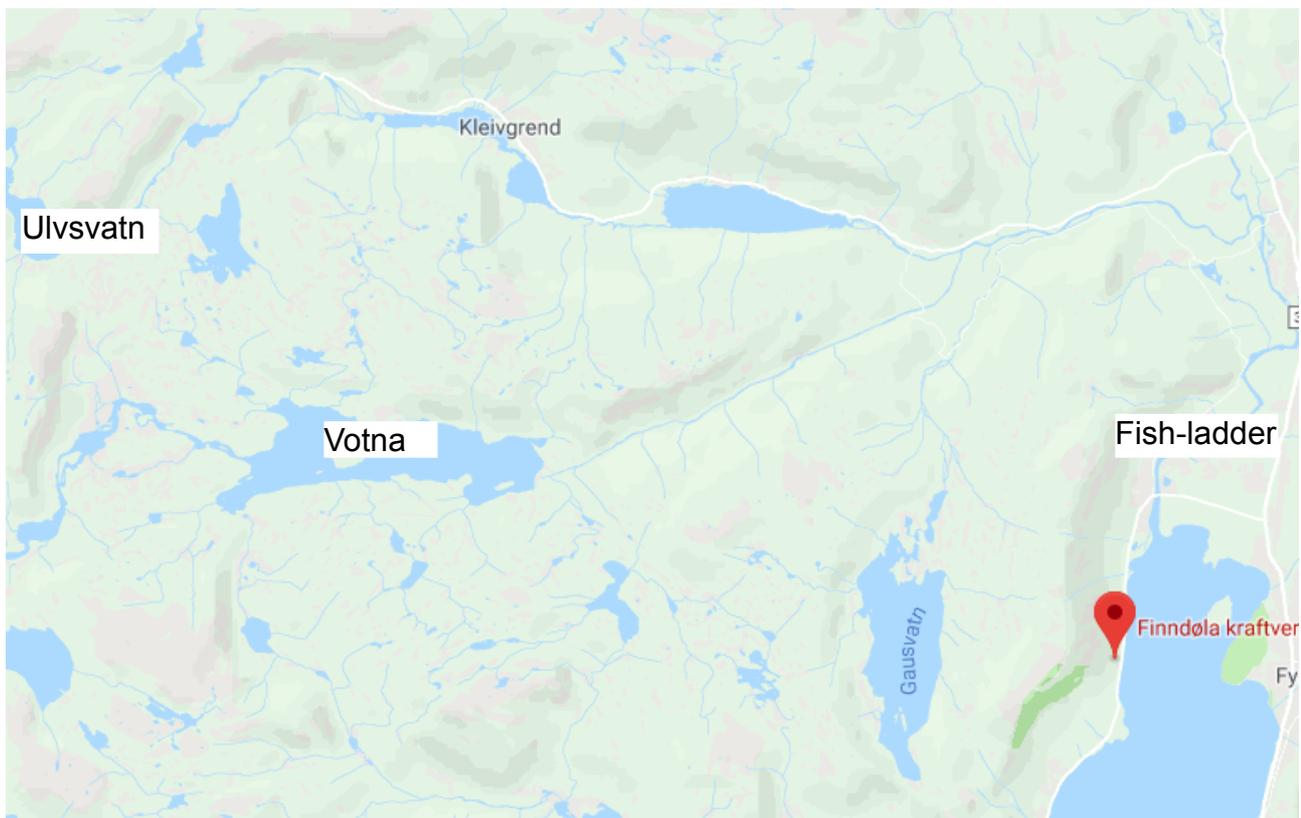
Figure 1. A map of the Finndøla catchment area. Red place marker indicates the location of the power plant.

Finndøla powerplant has its water intake in Gausvatn reservoir (that also collects water from Gromvatn and Votna reservoirs) and water outlet in Fyresvatn reservoir. The original flow out from Gausvatn is north, to rivers Gausåni, Finndøla and Bondøla. There is a dam here today. There is also a dam at Ulvsvatn – upstream from Bondøla river (see Figure 1 for an annotated map).
